Zueitina Terminal achieved US \$700,000 savings from automated tank cleaning

Libyan Zueitina Terminal asked Oreco business partner VAOS Ltd. (Value-Added Oil Service) to clean a crude oil storage tank of 79,000 m³ capacity, with 5,300 m³ sludge content. VAOS purchased the BLABO® system from Oreco early in the year 2003, and since then has relied on it for this type of project.

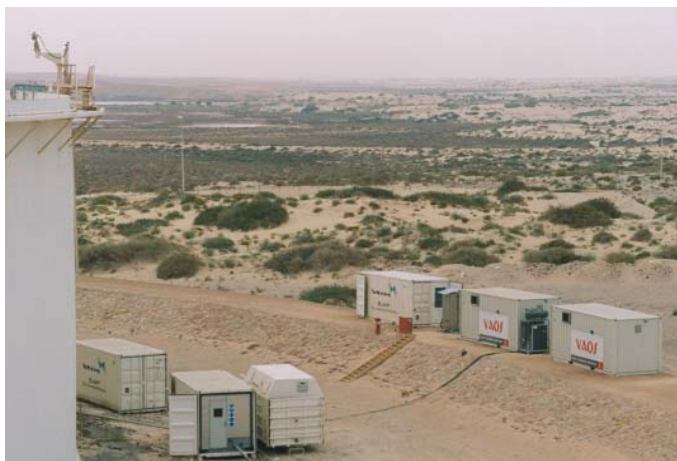
The BLABO® system in function at the Zueitina Terminal.

Oreco's BLABO® technology is a turn-key system for the automated cleaning of large, "difficult-to-clean" above-ground tanks storing crude oil and heavy fuel oil. In one safe and environmentally friendly process, the systems desludge, clean and recover hydrocarbons – and no one needs to enter the tanks at all. Using the BLABO® system, VAOS cleaned the tank recovering 4,969 m³ of crude oil for Zueitina. Throughout the entire project, no VAOS workers ever had to enter the tank or risk exposure to potentially harmful substances.

A double-deck tank roof made installation of BLABO's roof-installed cleaning nozzles difficult.

To complicate matters further, leaks in Zueitina's tank roof made it hard to bring down oxygen levels. VAOS used Oreco's "SafeTap" method of cutting through, rendering the process safe and efficient.
